**VILLAGE OF CHAGRIN FALLS
CEMETERY COMMISSION
August 14, 2019**

From: C. McGinnis, P.E.
To: Tim Lannon, Village Engineer
CC: John Lillash
Subject: Summary of Cemetery Building Review (19000601, Ph-07)
Location: Evergreen Hill Cemetery, Chagrin Falls, OH
Reason: Transformation of Existing Structure Into a Vault Columbarium (By Others)
Observation Date: 7/16/19
Observation By: C McGinnis & John Lillash

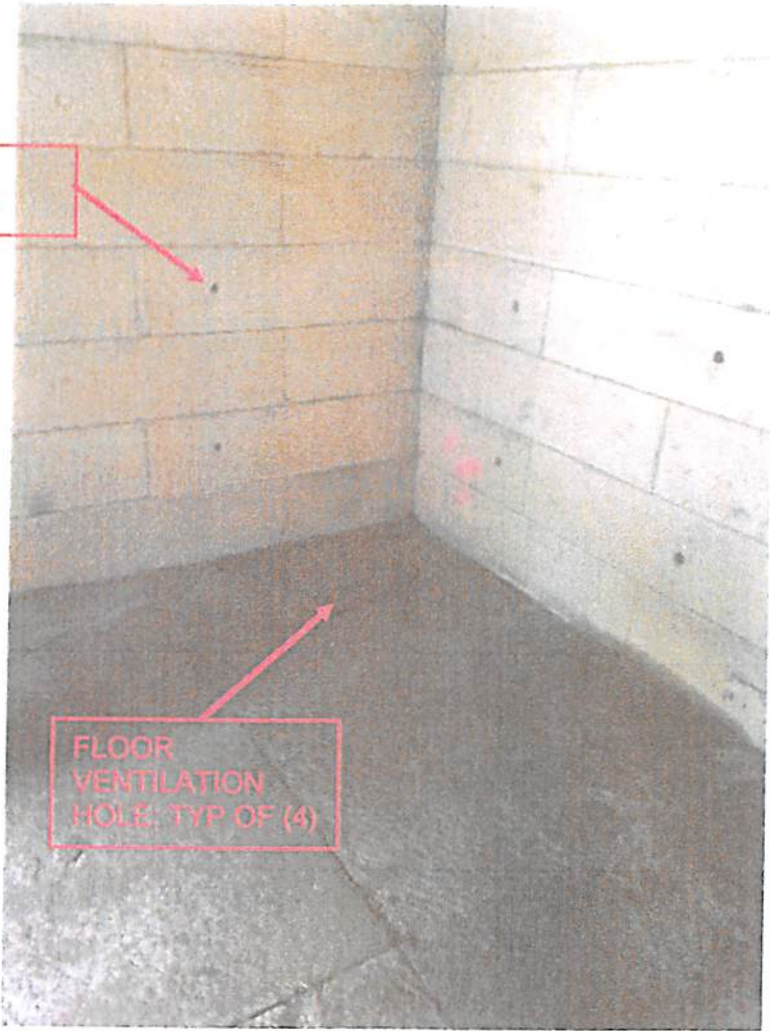
- Solid 18" thick block/mortar walls with front double leaf caged entrance door, no window openings and (2) 6" dia. foundation ventilation openings at each end of both long walls. The interior face of the second and fourth masonry courses contained 1 ½" dia. holes, 8"-9" deep, at approximately 2' spacing which are understood to be dowel/pin support holes for removable mortuary tables.

DOWEL/PIN
HOLES; TYP
