**VILLAGE OF CHAGRIN FALLS
CEMETERY COMMISSION
August 14, 2019**

From: C. McGinnis, P.E.
To: Tim Lannon, Village Engineer
CC: John Lillash
Subject: Summary of Cemetery Building Review (19000601, Ph-07)
Location: Evergreen Hill Cemetery, Chagrin Falls, OH
Reason: Transformation of Existing Structure Into a Vault Columbarium (By Others)
Observation Date: 7/16/19
Observation By: C McGinnis & John Lillash

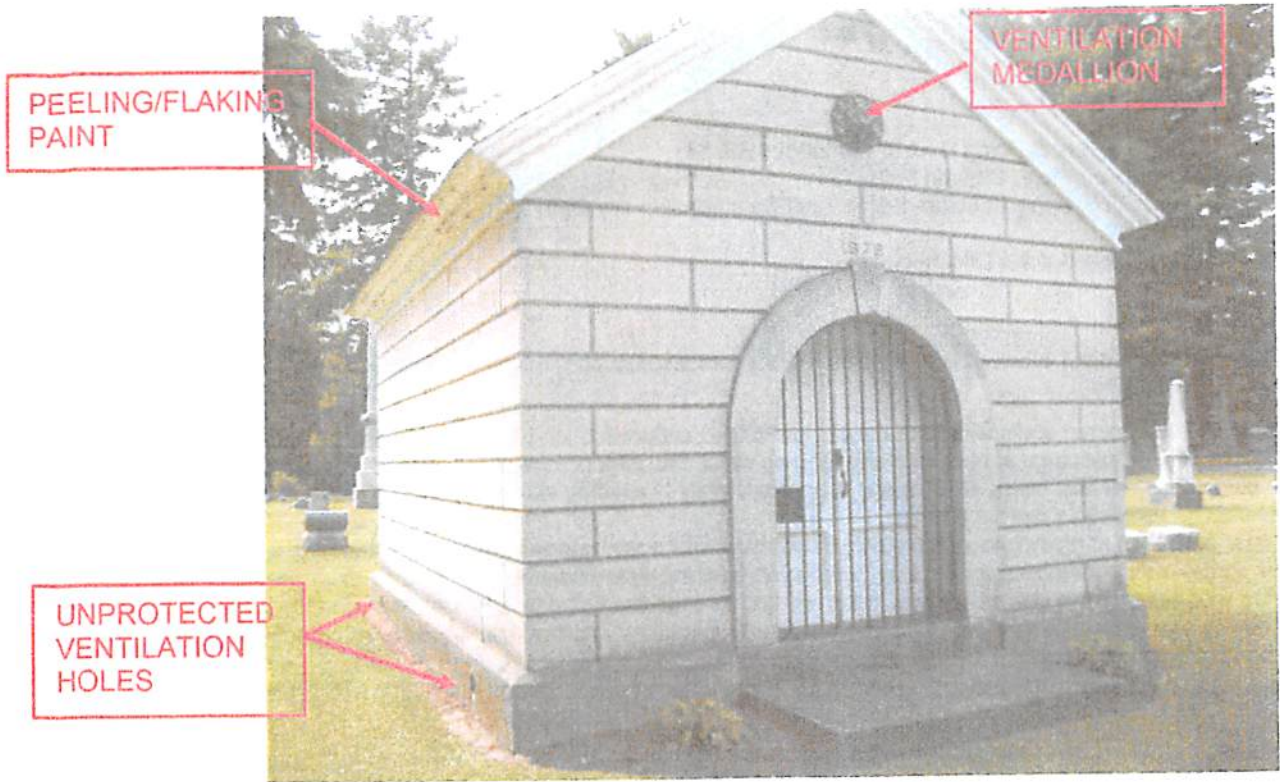
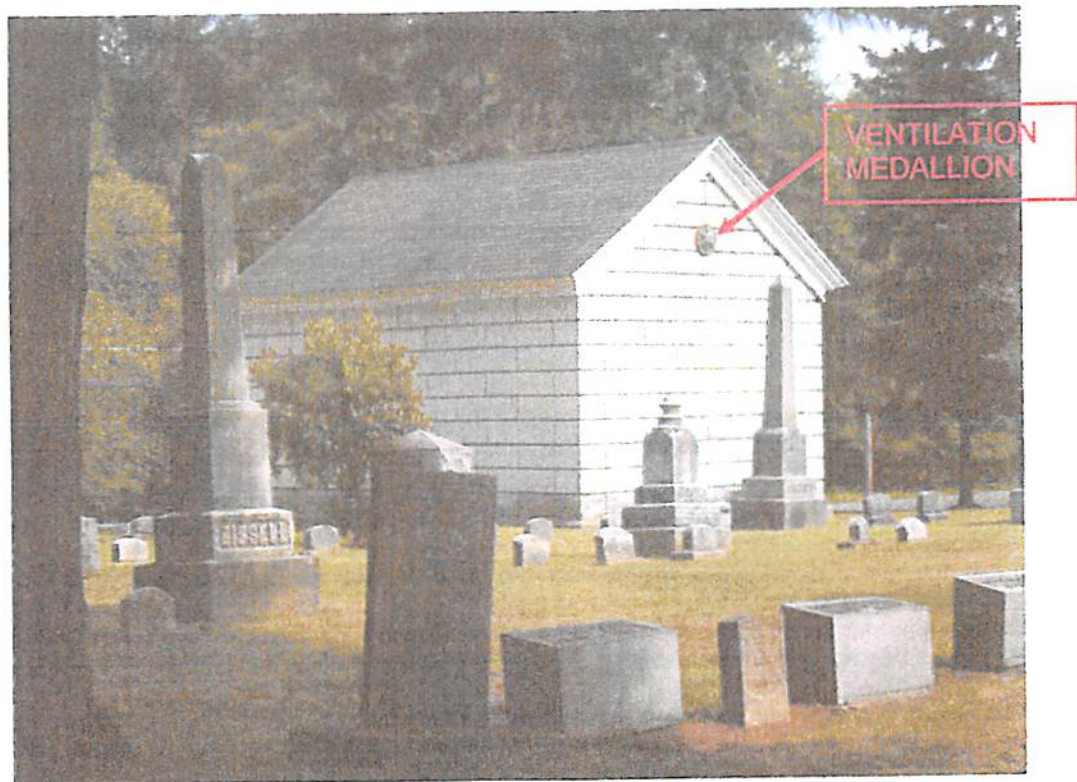
DOWEL/PIN
HOLES; TYP

- Solid 18" thick block/mortar walls with front double leaf caged entrance door, no window openings and (2) 6" dia. foundation ventilation openings at each end of both long walls. The interior face of the second and fourth masonry courses contained 1 ½" dia. holes, 8"-9" deep, at approximately 2' spacing which are understood to be dowel/pin support holes for removable mortuary tables.

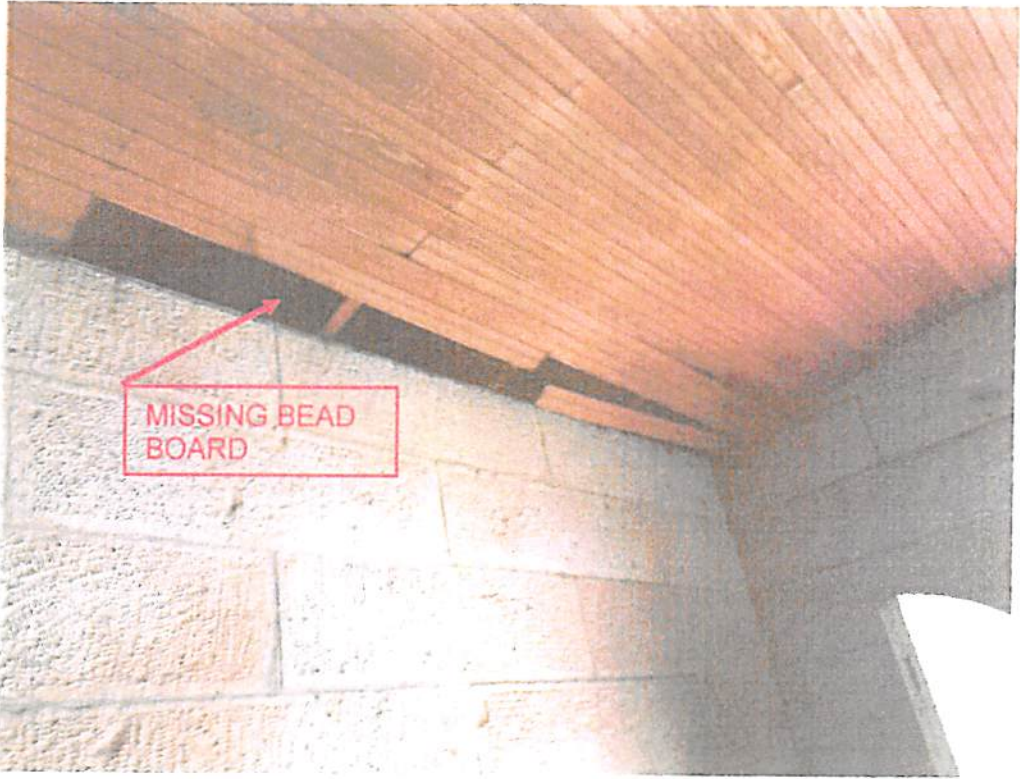
- Exterior foundation ventilation openings require louvered covers for rodent control.
- Interior bead board ceiling contained a couple of demolition/access holes that require patch/repair.

LOOSE
VENTILATION
GUARD

UNPROTECTED
VENTILATION
HOLE
